WATER DAMAGE/REMEDATION ASSESSMENT

**Memorial Middle School
81 Central Avenue
Hull, Massachusetts**

Prepared by:
Massachusetts Department of Public Health
Bureau of Environmental Health
Indoor Air Quality Program
February 2018

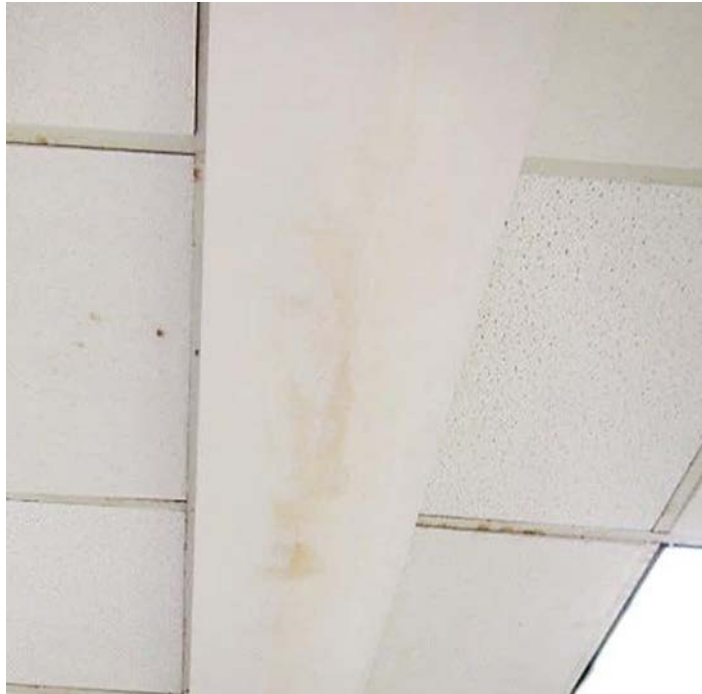
Picture 1

Evidence of water leaks in the form of staining on ceiling surfaces was observed in the cafeteria (Picture 1). The ceiling appears to consist of metal and plaster, which are considered to be materials that do not become mold colonized if wet. No current signs of water damage and/or mold growth were observed on the ceiling or in the ceiling plenum by BEH/IAQ staff. Water most likely penetrated through breaches in exterior walls in the cafeteria during heavy

Staining of ceiling surface (metal)

2. Once repointing/repairs are made, seal and repaint areas of water stains in cafeteria.
3. Continue to monitor historic areas of leaks and damage/mold growth to porous classroom materials (e.g., books in ELA classroom 238/Picture 6), relocate if necessary.

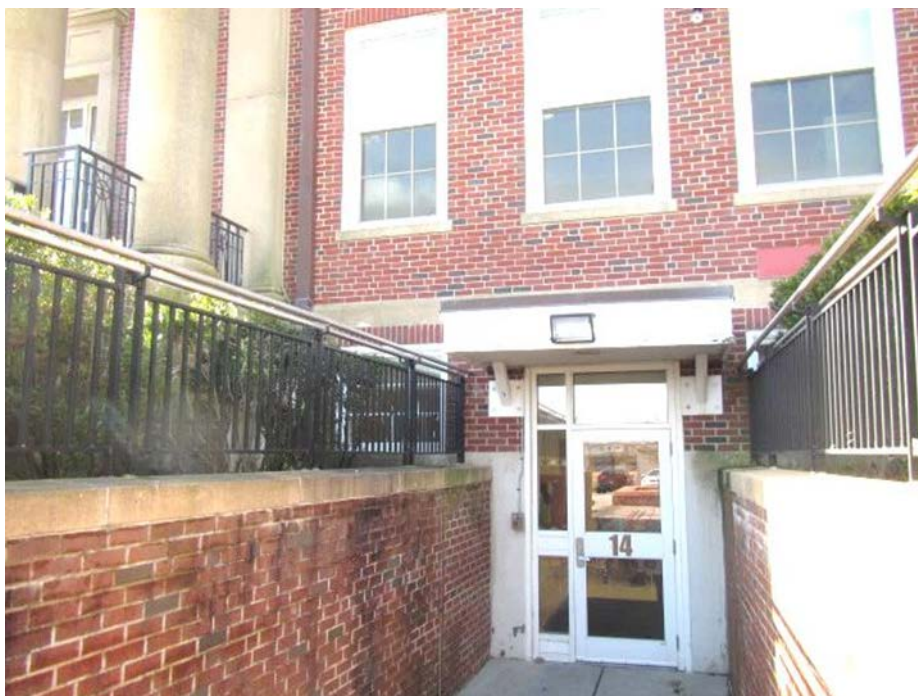
Picture 2

wind/weather events (Pictures 2 and 3). Hull school officials reported that water-proofing/repointing work is planned to occur during the summer of 2018.

Area outside of cafeteria where water staining was observed

1. Continue with plans to water-proof/repoint exterior brickwork and building envelope repairs.

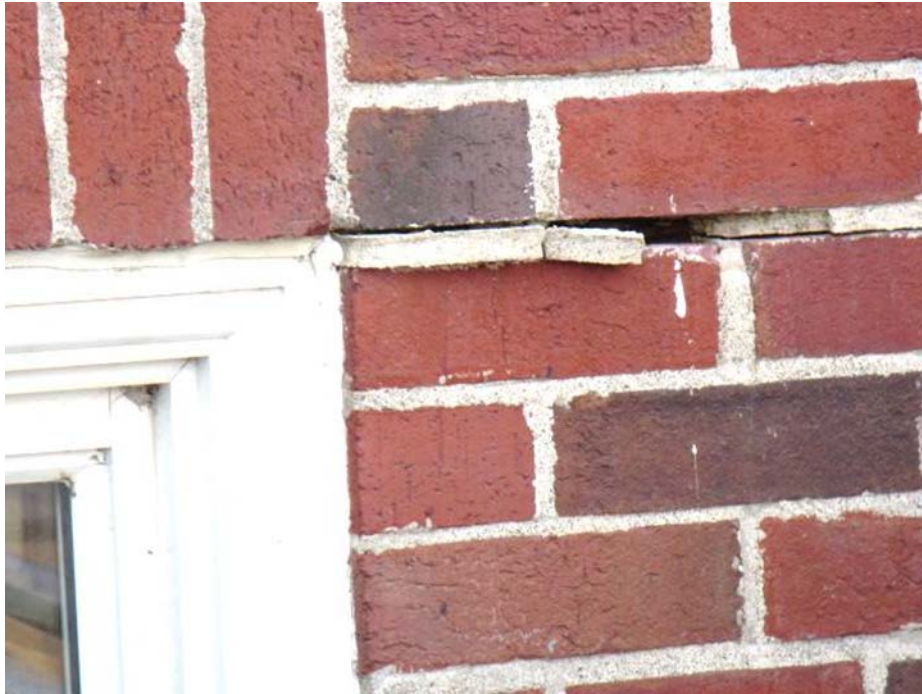
Picture 3

Missing/damaged mortar around brick outside cafeteria

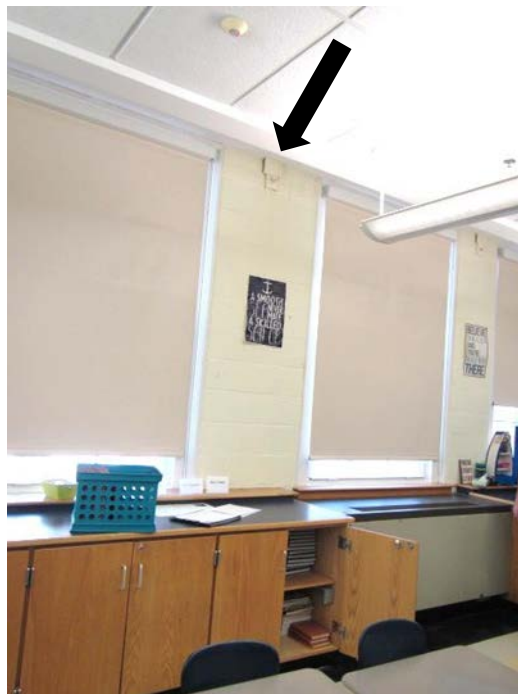
Picture 4

The ELA classroom (238) had evidence of water penetration in the form of staining on ceiling concrete and plaster (Pictures 4 and 5). Although this source of leaks should be addressed to avoid damage/staining of ceiling/wall surfaces, there were no porous building materials that can support mold growth (e.g., carpet, ceiling tiles, drywall) in the affected areas. Below the water stain is a wood cabinet containing text books (Picture 6). BEH/IAQ staff thoroughly examined materials stored in the cabinets and found no evidence of water damage/mold growth.

ELA classroom 238, arrow indicates area of water staining

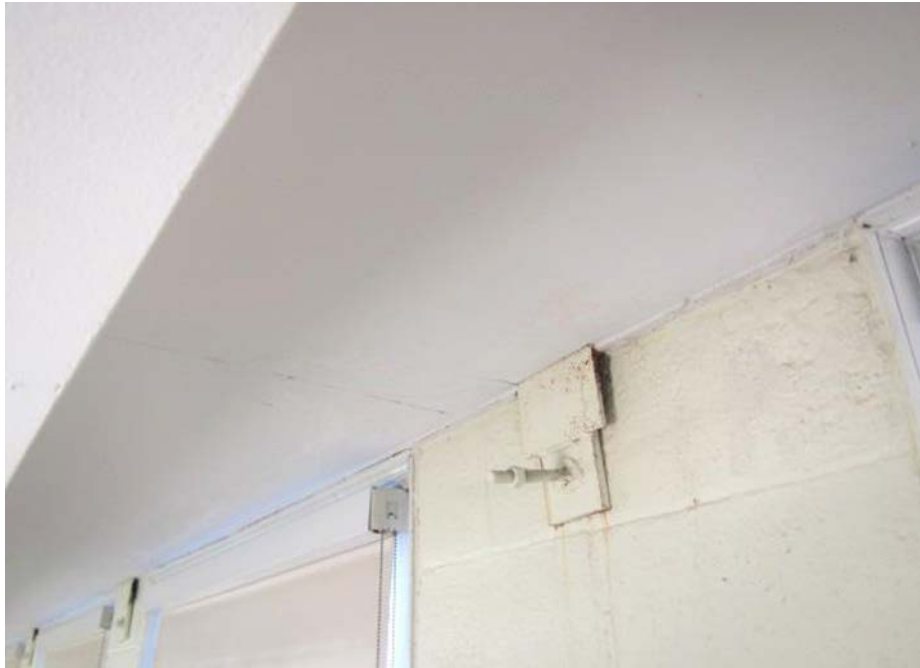
Picture 5

Close up of ELA classroom 238 area of water staining, note non-porous concrete and plaster building materials

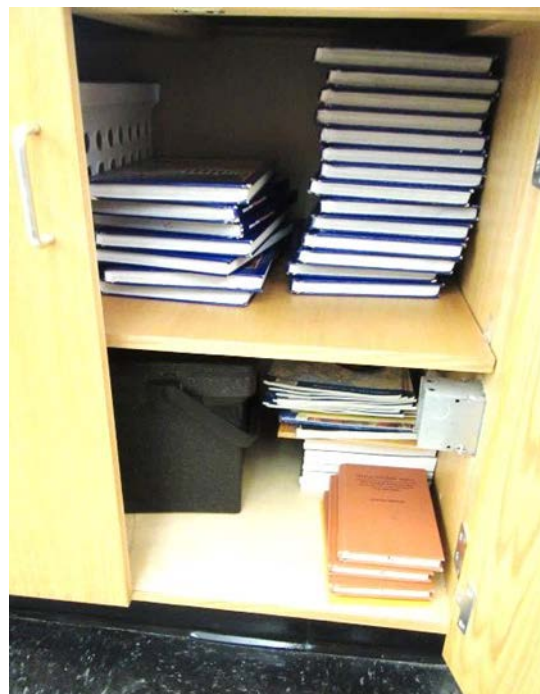
Picture 6

Textbooks in wooden cabinet directly beneath area of reported leaks

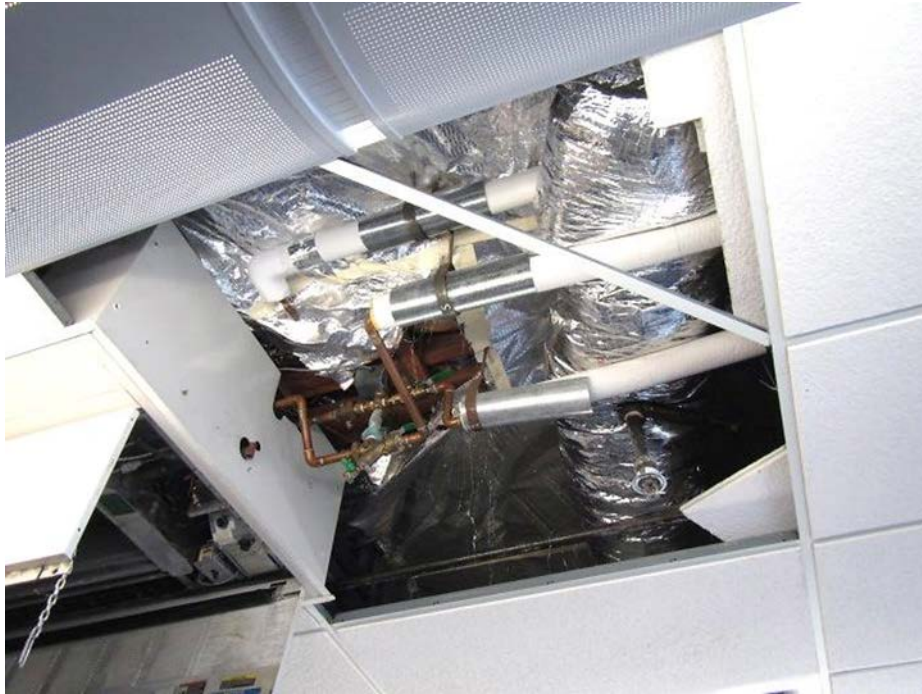
Picture 7

The Spanish classroom was reported to have had a pipe burst due to extreme cold during the first week of January 2018. As a result, ceiling tiles and carpeting were water-damaged. School officials, reported that Service Master, a flooding restoration company, responded to perform remediation/drying efforts. As mentioned, the MDPH/BEH assessment occurred on Monday February 5, 2018, it was reported a second leak occurred in the room (Picture 7) due to freezing of pipes over the weekend prior to the visit. Upon discovery of this subsequent pipe leak, maintenance personnel reportedly shut off the water source and conducted drying operations of carpeting. At the time of assessment, the classroom occupants had been relocated so repairs could be made. Moisture testing by BEH/IAQ staff was done and all building materials were dry (e.g., carpeting, ceiling tiles) and no visible mold growth/odors were observed.

Pipes above ceiling in Spanish classroom that froze

4. Continue to make repairs to HVAC unit in Spanish classroom.
5. Determine why pipe freezes are reoccurring (lack of insulation, drafts/breaches in building envelope, etc.), and make repairs/modifications as needed.
